# Updated Report For 2011

## EIFS Cladding Evaluation

Illinois, Wisconsin, Iowa,  
Michigan, Indiana

Sam A. Sample

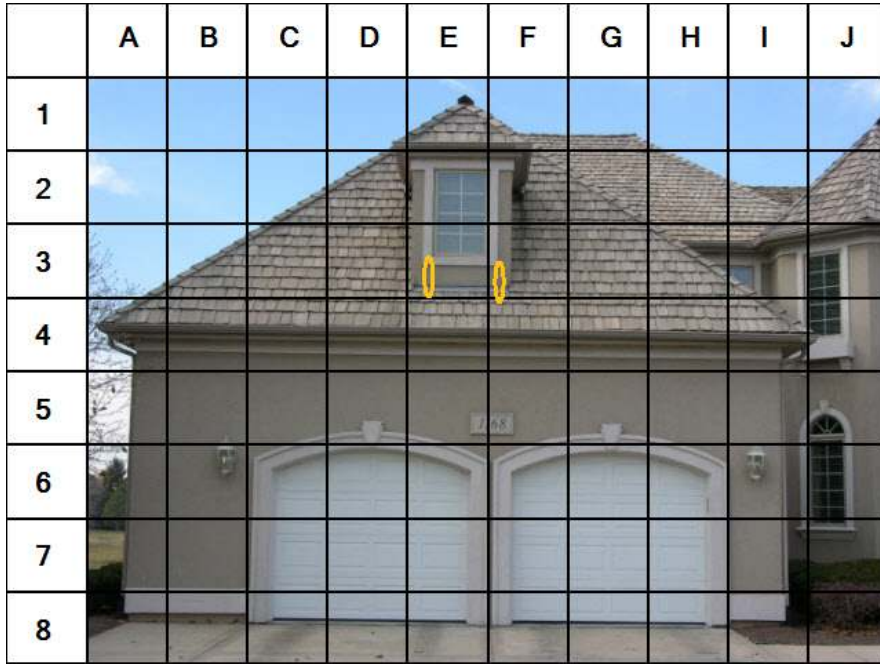
Grid Location	Item Description	Moisture Readings	Substrate Condition	Observations/Comments
E3	Windows	7.5	Firm	
F3	Windows	7.9	Firm

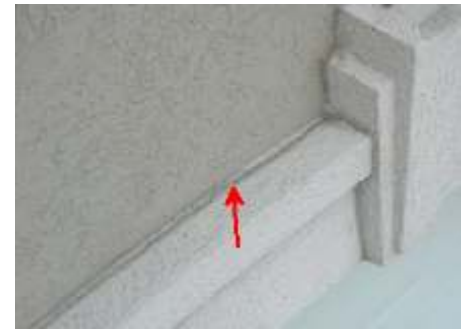
Seal flat junctions.

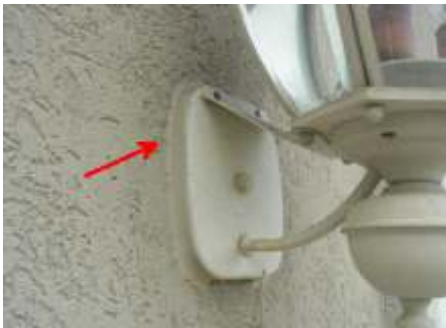
Remove and replace attachments or fixture sealants.

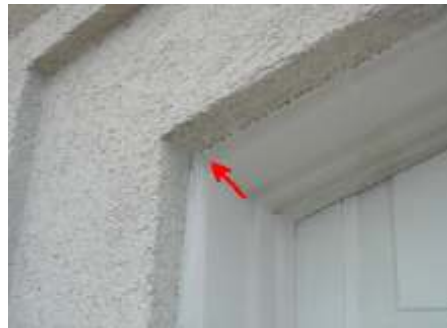
Remove and replace door perimeter sealants.

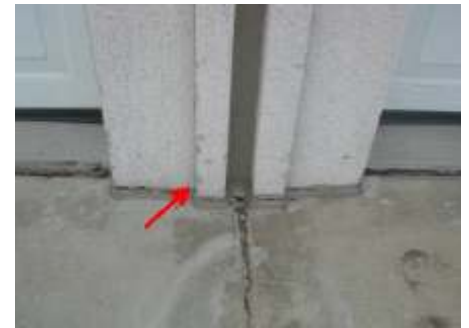
Cut up and repair door trim terminations.

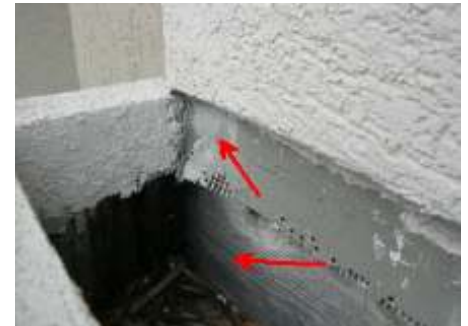
Planter boxes are improperly installed and need to be removed or corrected.

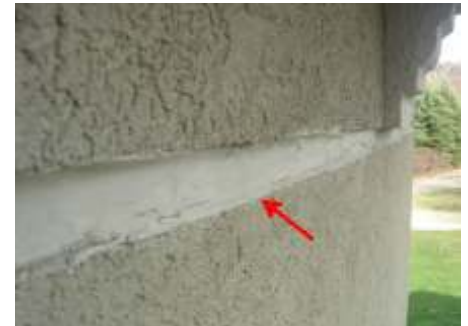
Expansion joint sealants need to be removed and replaced.

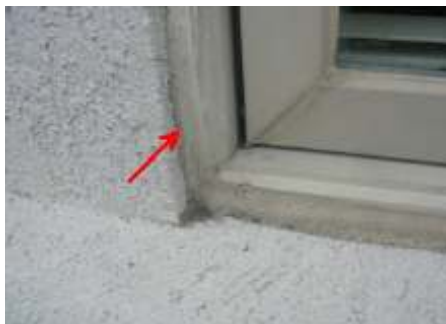
Remove and replace window perimeter sealants.

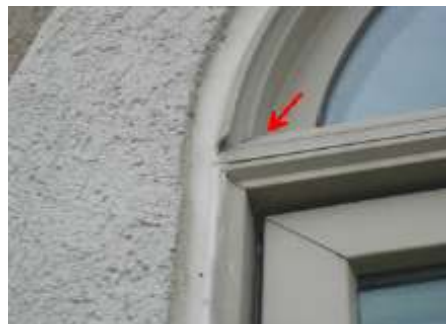
Suggest sealing all window construction joints.

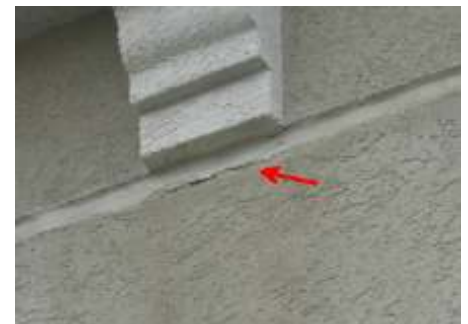
Failing expansion joint sealants under planter boxes.

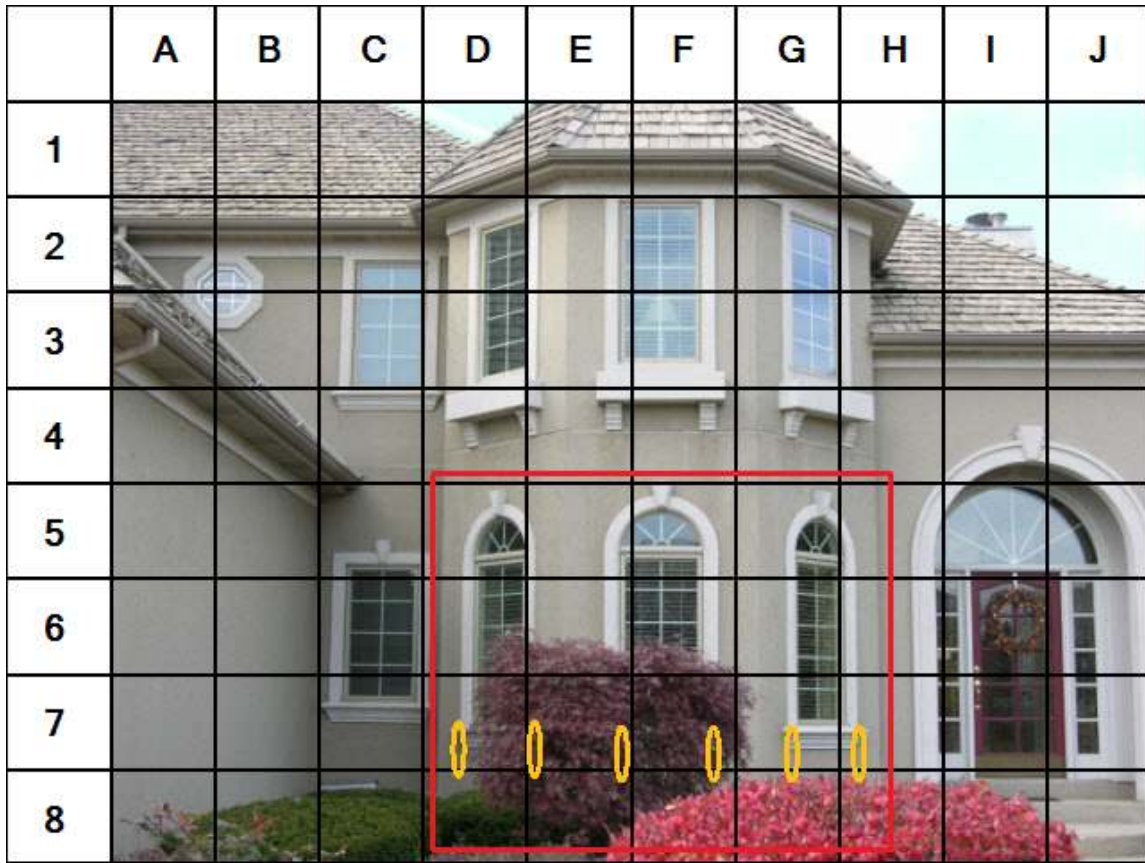
Grid Location	Item Description	Moisture Readings	Substrate Condition	Observations/Comments	
D7	Window	13	Med	Substrate has been softened due to moisture entry from above. The repair contractor will need to verify all of the substrate in this area.	Red box
E7L	Window	17	Med		
E7R	Window	9.1	Med		
F7	Window	12	Med		
G7	Window	11.4	Med		
I7	Window	9.5	Med

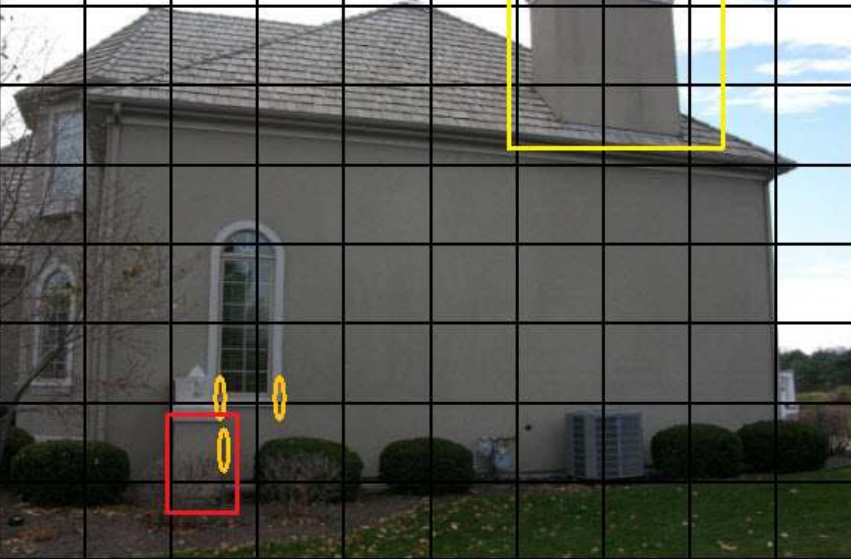
Grid Location	Item Description	Moisture Readings	Substrate Condition	Observations/Comments	
C6	Window	10	Firm		
D6	Window	16	Firm		
C7	Decorative column	40	Soft	Moisture damaged column will need to be repaired.	Red box
Yellow Box	Chimney			No good access to the chimney for moisture testing. Contactor please evaluate further and correct as necessary.

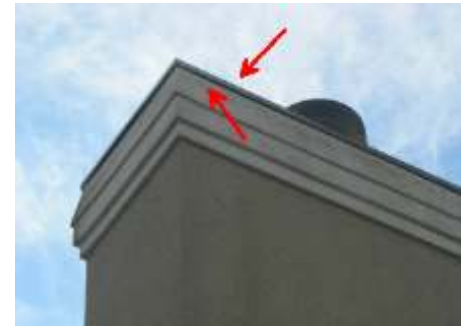
Check cap for leaks real fasteners and gaps as necessary.

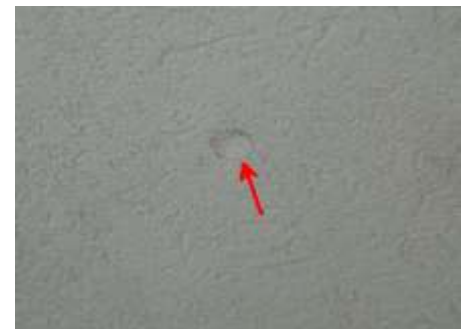
Repair all impact damage.

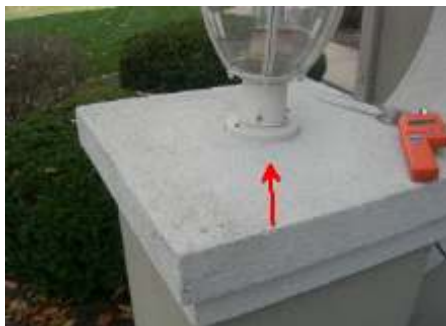
Waterproof flat surfaces.

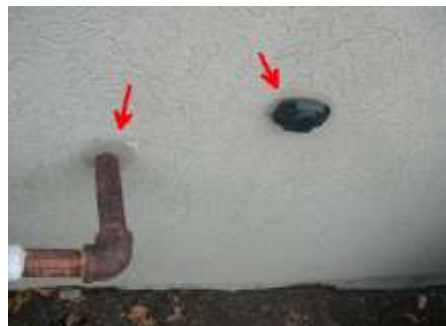
Remove and replace sealants at all siding penetrations.

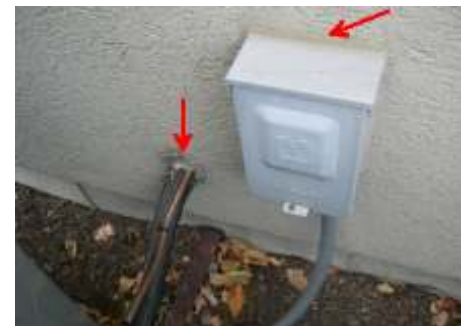
Remove and replace sealants at all utilities.

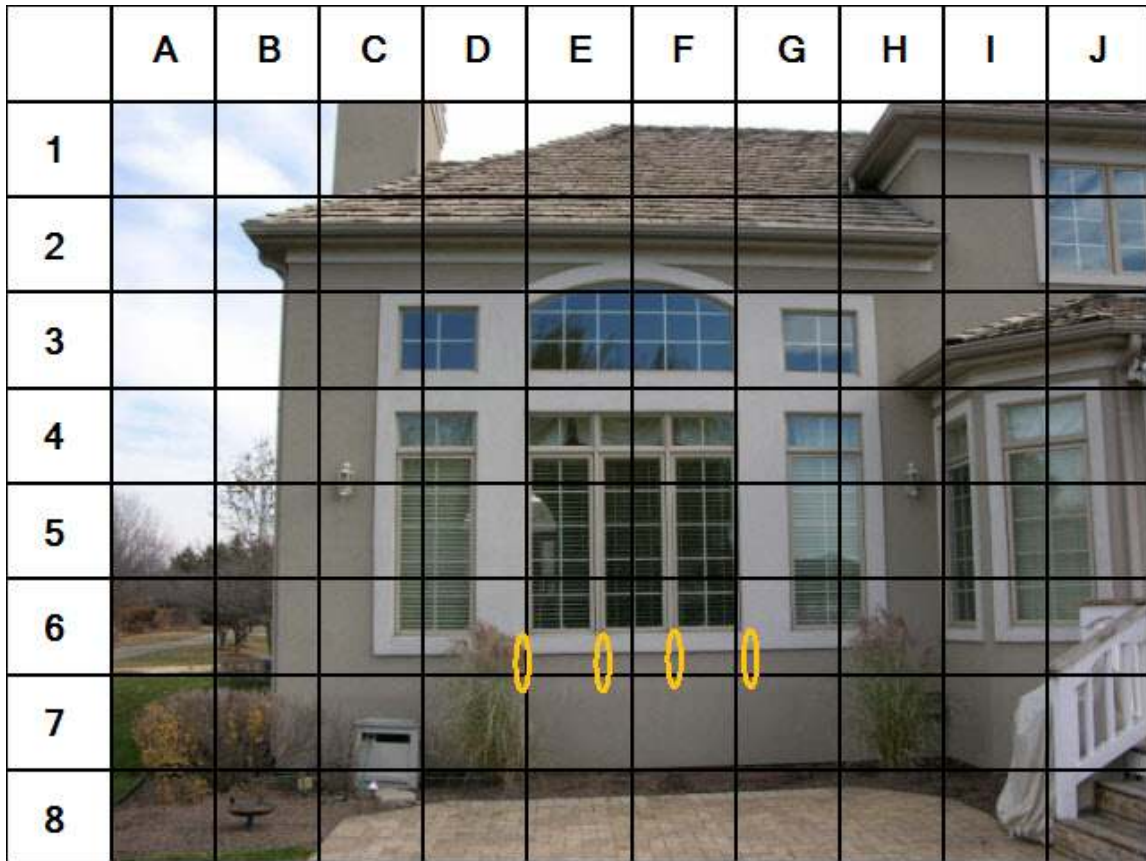
Grid Location	Item Description	Moisture Readings	Substrate Condition	Observations/Comments
D6	Window	8.8	Firm	
E6	Window	16	Firm	
F6	Window	9.0	Firm	
G6	Window	18	Firm

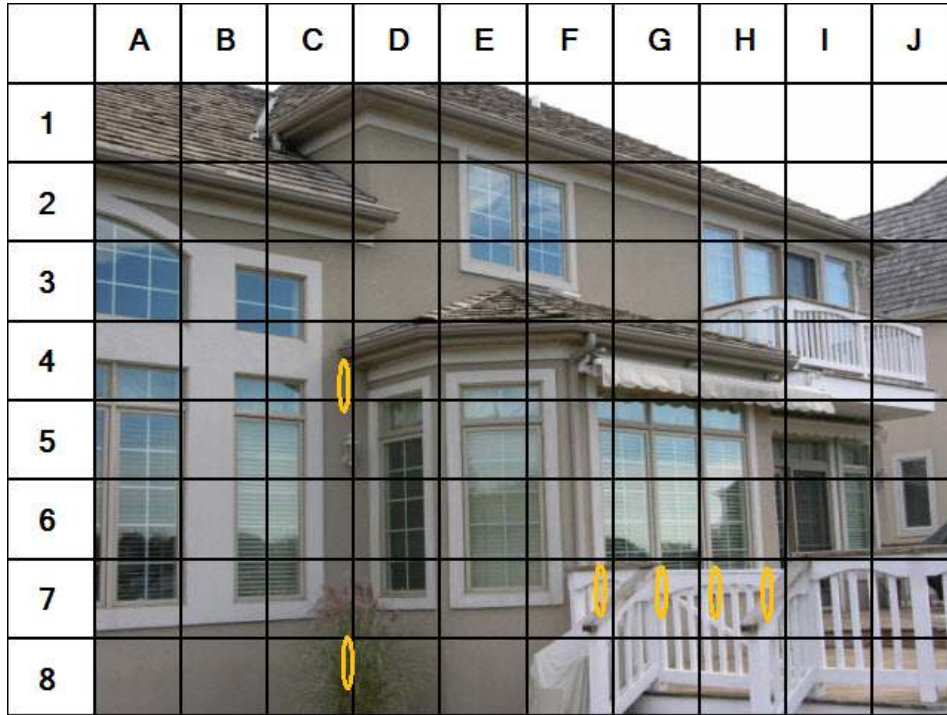
Grid Location	Item Description	Moisture Readings	Substrate Condition	Observations/Comments
C4	Kickout	8.1	Firm	
C8	Kickout	7.0	Firm	
F7	Window	7.9	Firm	
G7	Window	8.0	Firm	
H7L	Window	9.1	Firm	
H7R	Window	10	Firm

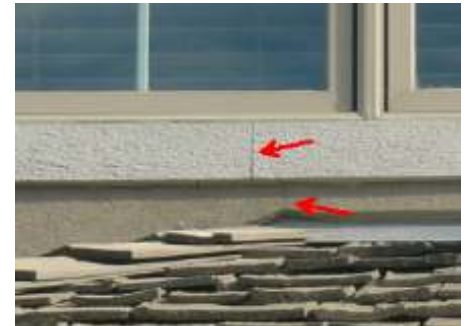
Repair cracking under rear window.

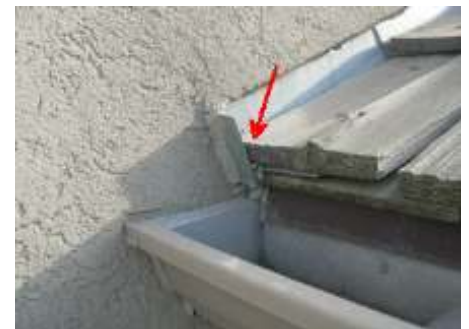
Install new flashing to meet manufacturer specifications.

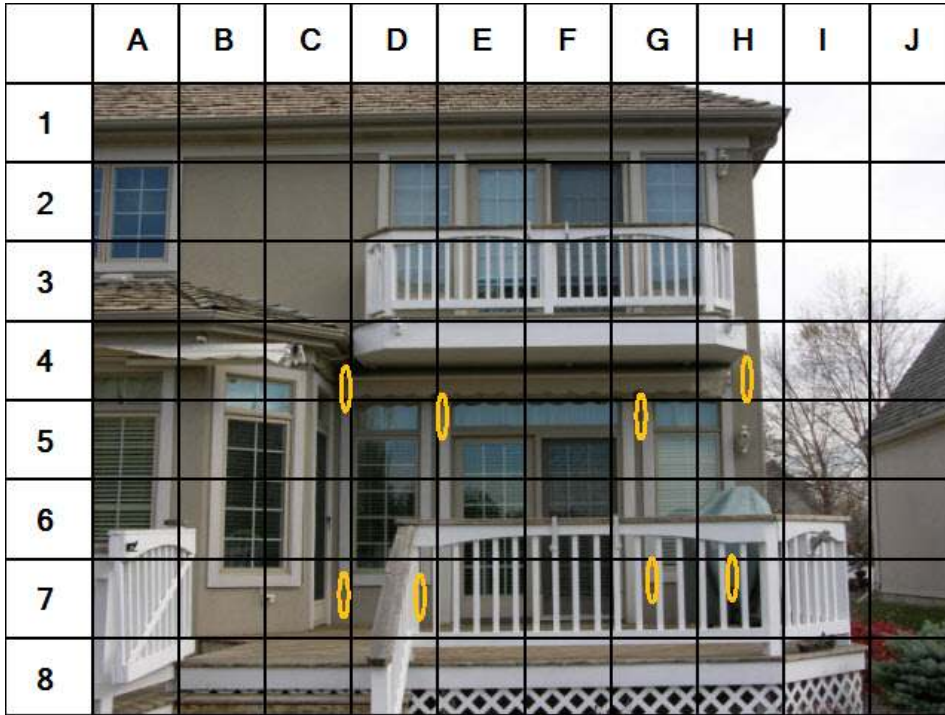
Grid Location	Item Description	Moisture Readings	Substrate Condition	Observations/Comments
C4	Kickout / Balcony	9.2	Firm	
H4	Balcony	8.4	Firm	
E5	Balcony	25	Soft	Further evaluation needed by the contractor under balcony.
G5	Balcony	18	Firm	
C7	Window	14	Firm	
D7	Window	40	Soft	
G7	Window	18	Soft	
H7	Window	16	Soft

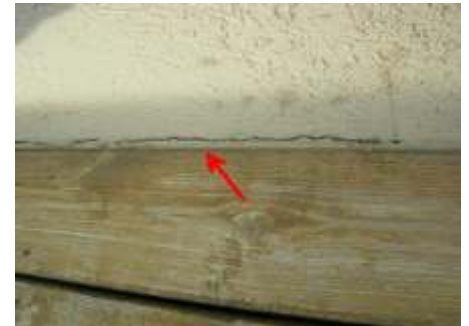
Crack in balcony sealants. No evidence of wall flashing.

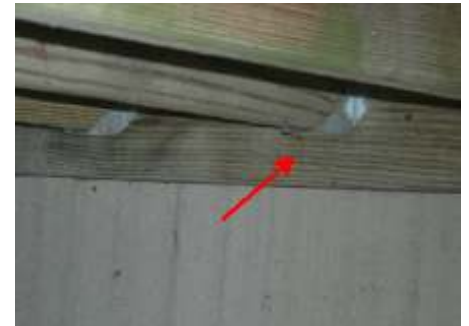
Deck is attached to the eifs. No evidence of flashing.

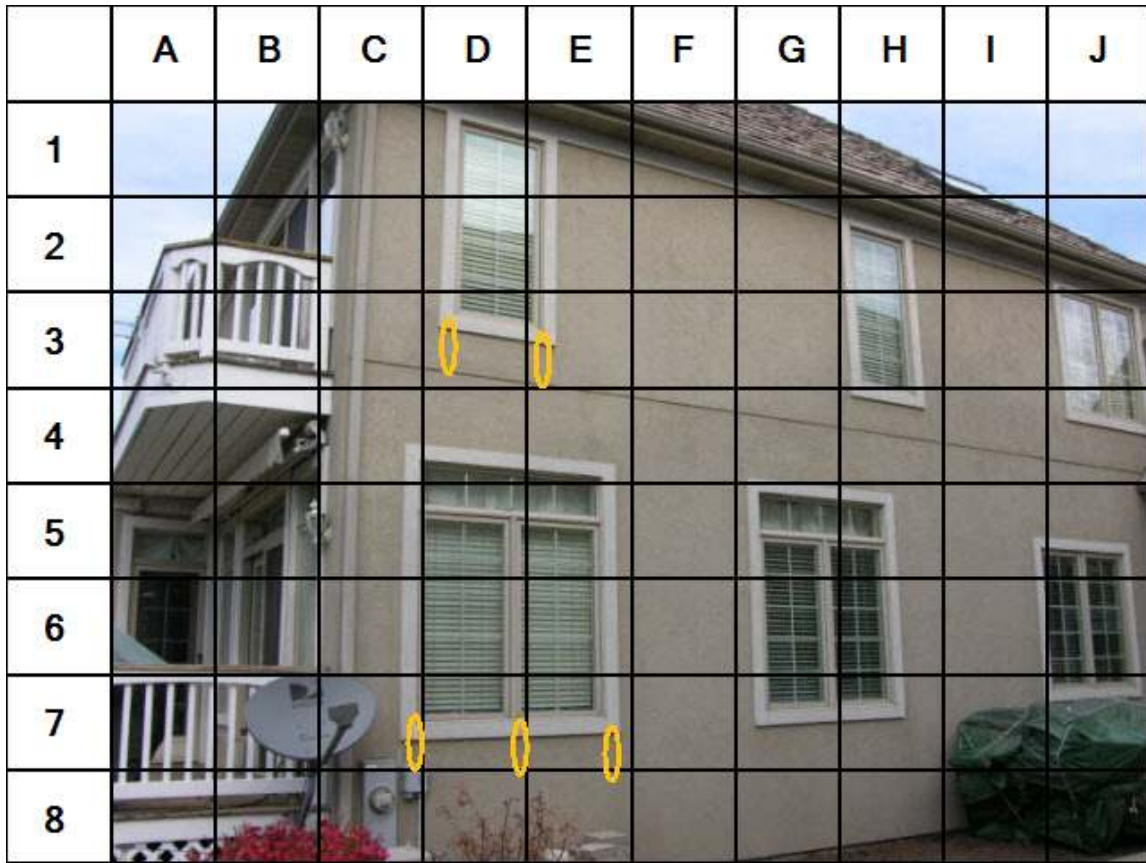
Grid Location	Item Description	Moisture Readings	Substrate Condition	Observations/Comments
D3	Window	5.9	Firm	
E3	Window	6.8	Firm	
C7	Window	14.4	Firm	
D7	Window	8.0	Firm	
E7	Window	15	Firm

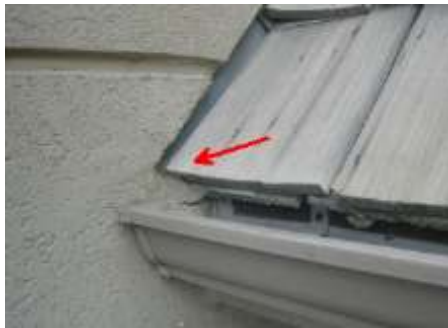
Missing flashing. Install proper kickout flashing.

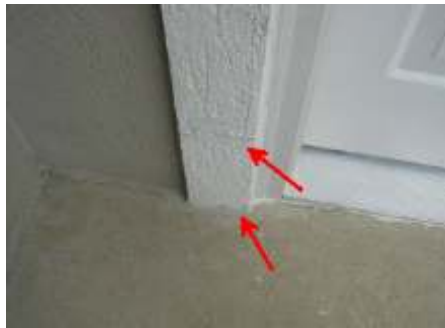
Repair cracking and correct termination at rear garage door.

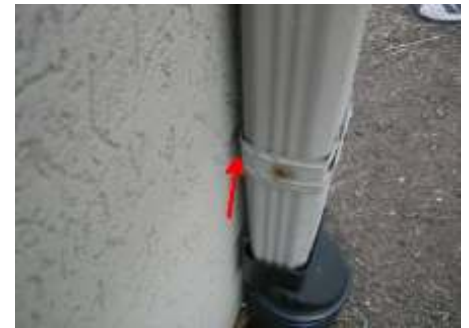
Seal all downspout fasteners.
